CITY OF EMERYVILLE

MEMORANDUM

SUBJECT: Discussion of Parkside Park Design and Removal of Existing Trees

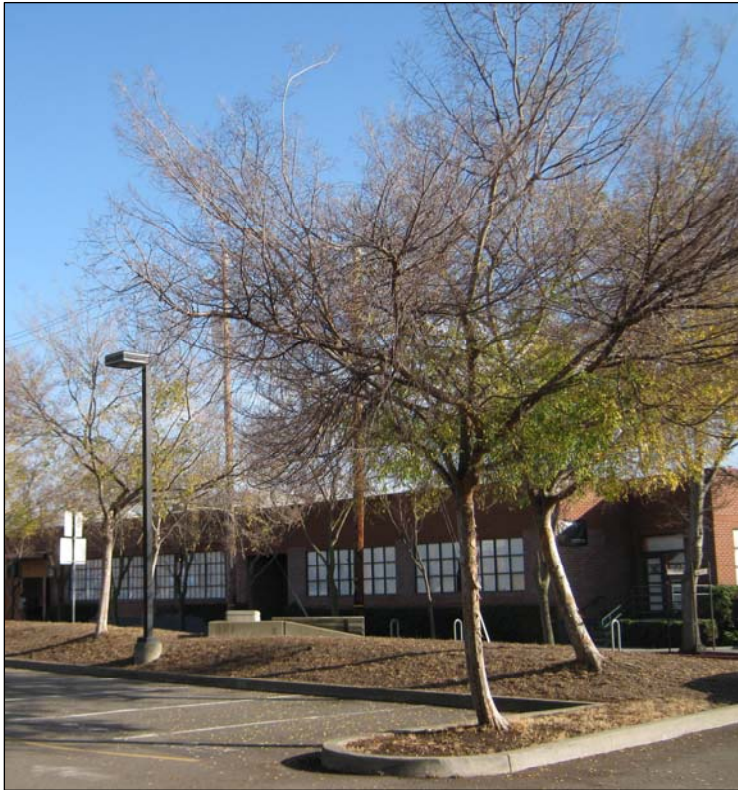
Chinese elm, with 22 trees, was the most commonly encountered species. These were young trees, with diameters between 6" and 12", planted in and around the parking lot. The trees were in good (18 trees) to fair condition (4 trees). Sixteen (16) were growing on a raised berm along the southern edge of the parking lot, and had been provided adequate space to develop good form and structure (Photo 1). Two (2) trees had been planted adjacent to the building and leaned to the south (#1 and 19).

Photo 1. Chinese elms #3 (foreground), 4 (middle) and 5 (background left), were typical of the species at the Parkside Park site. Most of the Chinese elms had been planted along the berm between the parking lot and Stanford Avenue. The trees were young and had performed well.

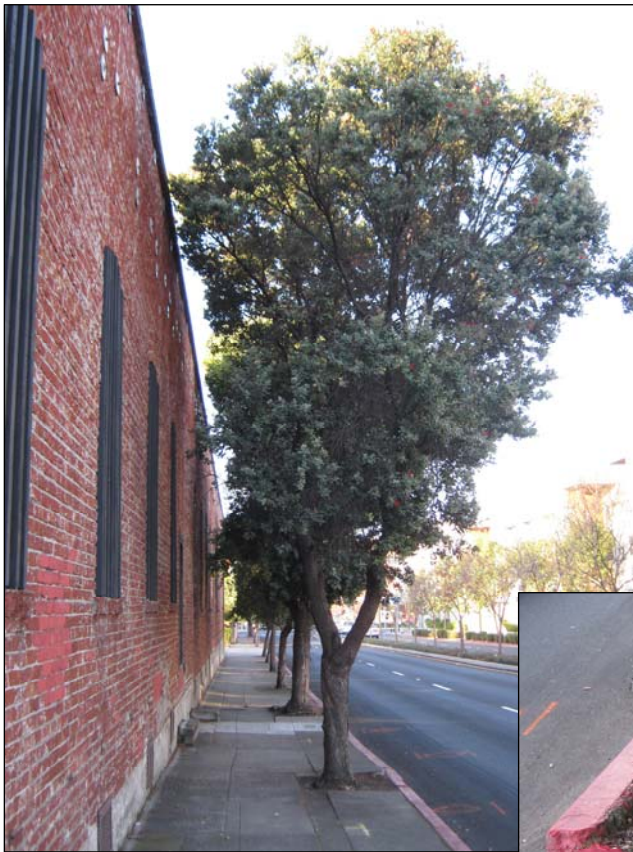
Street trees included eight (8) New Zealand Christmas trees, two (2) callery pears and one (1) cork oak. Overall, street trees were in good condition. The New Zealand Christmas trees and the cork oak had been planted along Powell St., and the Callery pears on Doyle Street. All had been planted in small tree wells, and five (5) of the New Zealand Christmas trees were displacing the sidewalk, curb and gutter 1-5" (Photo 2, inset). The trees were one-sided north, away from the building and had been pruned on the north side by the trucks travelling east on Powell St. (Photo 2, following page).

Photo 2. Street trees included eight (8) New Zealand Christmas trees and one (1) cork oak along Powell St., and two (2) Callery pears on Doyle Street. The trees had performed well, despite the tough growing conditions. Inset shows the base of tree #36, which had displaced the sidewalk and curb by approximately 5”.

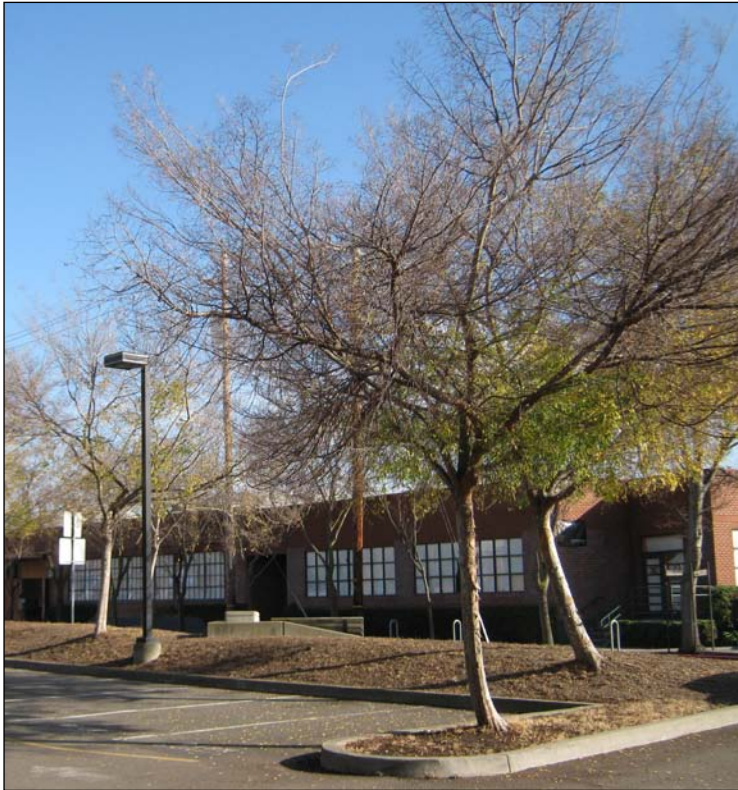
Chinese elm, with 22 trees, was the most commonly encountered species. These were young trees, with diameters between 6" and 12", planted in and around the parking lot. The trees were in good (18 trees) to fair condition (4 trees). Sixteen (16) were growing on a raised berm along the southern edge of the parking lot, and had been provided adequate space to develop good form and structure (Photo 1). Two (2) trees had been planted adjacent to the building and leaned to the south (#1 and 19).

Photo 1. Chinese elms #3 (foreground), 4 (middle) and 5 (background left), were typical of the species at the Parkside Park site. Most of the Chinese elms had been planted along the berm between the parking lot and Stanford Avenue. The trees were young and had performed well.

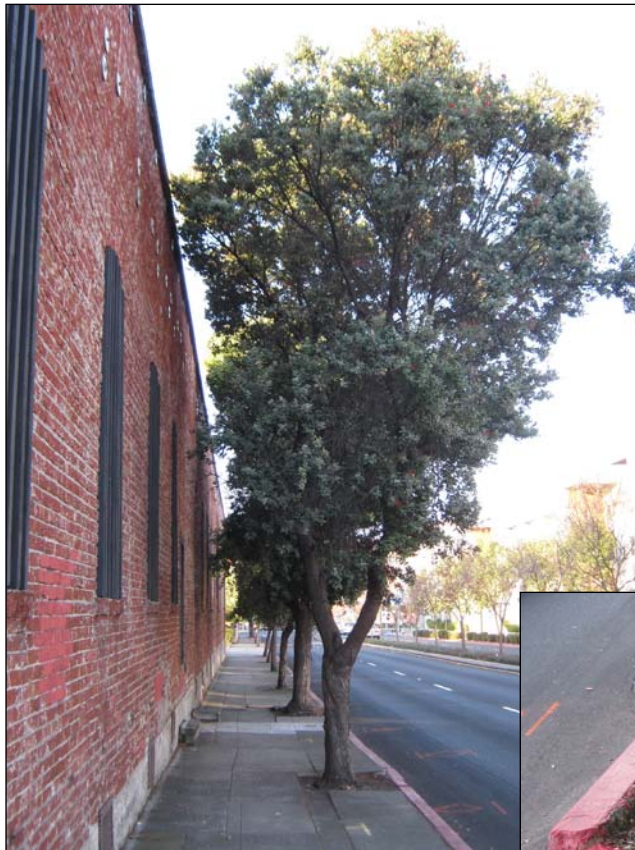
Photo 2. Street trees included eight (8) New Zealand Christmas trees and one (1) cork oak along Powell St., and two (2) Callery pears on Doyle Street. The trees had performed well, despite the tough growing conditions. Inset shows the base of tree #36, which had displaced the sidewalk and curb by approximately 5”.

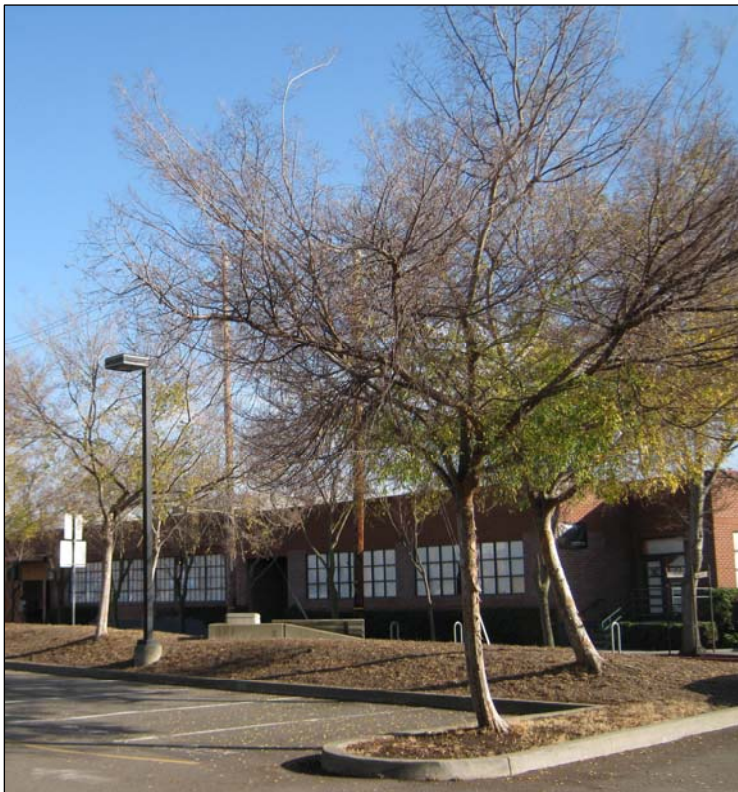
Chinese elm, with 22 trees, was the most commonly encountered species. These were young trees, with diameters between 6" and 12", planted in and around the parking lot. The trees were in good (18 trees) to fair condition (4 trees). Sixteen (16) were growing on a raised berm along the southern edge of the parking lot, and had been provided adequate space to develop good form and structure (Photo 1). Two (2) trees had been planted adjacent to the building and leaned to the south (#1 and 19).

Photo 1. Chinese elms #3 (foreground), 4 (middle) and 5 (background left), were typical of the species at the Parkside Park site. Most of the Chinese elms had been planted along the berm between the parking lot and Stanford Avenue. The trees were young and had performed well.

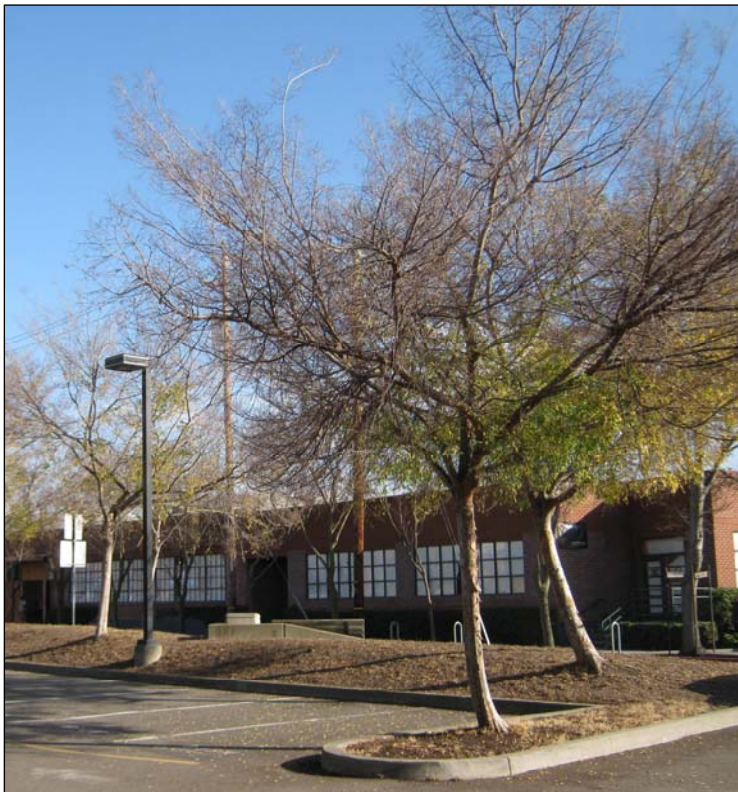
Chinese elm, with 22 trees, was the most commonly encountered species. These were young trees, with diameters between 6" and 12", planted in and around the parking lot. The trees were in good (18 trees) to fair condition (4 trees). Sixteen (16) were growing on a raised berm along the southern edge of the parking lot, and had been provided adequate space to develop good form and structure (Photo 1). Two (2) trees had been planted adjacent to the building and leaned to the south (#1 and 19).

Photo 1. Chinese elms #3 (foreground), 4 (middle) and 5 (background left), were typical of the species at the Parkside Park site. Most of the Chinese elms had been planted along the berm between the parking lot and Stanford Avenue. The trees were young and had performed well.
