CITY OF EMERYVILLE

MEMORANDUM

SUBJECT: Discussion of Parkside Park Design and Removal of Existing Trees

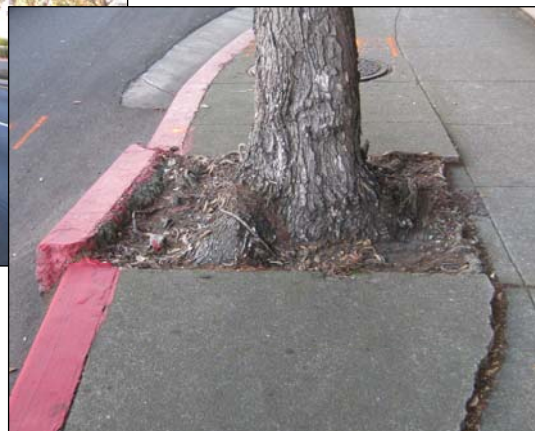
Street trees included eight (8) New Zealand Christmas trees, two (2) callery pears and one (1) cork oak. Overall, street trees were in good condition. The New Zealand Christmas trees and the cork oak had been planted along Powell St., and the Callery pears on Doyle Street. All had been planted in small tree wells, and five (5) of the New Zealand Christmas trees were displacing the sidewalk, curb and gutter 1-5" (Photo 2, inset). The trees were one-sided north, away from the building and had been pruned on the north side by the trucks travelling east on Powell St. (Photo 2, following page).

Photo 2. Street trees included eight (8) New Zealand Christmas trees and one (1) cork oak along Powell St., and two (2) Callery pears on Doyle Street. The trees had performed well, despite the tough growing conditions. Inset shows the base of tree #36, which had displaced the sidewalk and curb by approximately 5”.

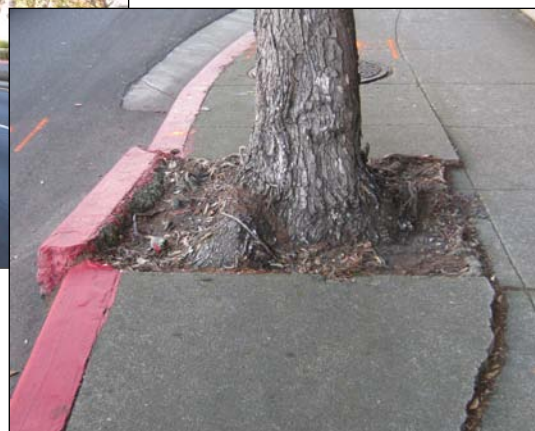
Street trees included eight (8) New Zealand Christmas trees, two (2) evergreen pears and one (1) cork oak. Overall, street trees were in good condition. The New Zealand Christmas trees and the cork oak had been planted along Powell St., and the evergreen pears on Doyle Street. All had been planted in small tree wells, and five (5) of the New Zealand Christmas trees were displacing the sidewalk, curb and gutter 1-5" (Photo 2, inset). The trees were one-sided north, away from the building and had been pruned on the north side by the trucks travelling east on Powell St. (Photo 2, following page).

Photo 2. Street trees included eight (8) New Zealand Christmas trees and one (1) cork oak along Powell St., and two (2) Callery pears on Doyle Street. The trees had performed well, despite the tough growing conditions. Inset shows the base of tree #36, which had displaced the sidewalk and curb by approximately 5”.
